Affidavit – James Barton 2 (May 15, 2008)

James Barton
Affidavit
RANGE VISIT TRACER TEST

After inspecting the FBI range facility on Monday, April 28
I made the following report:

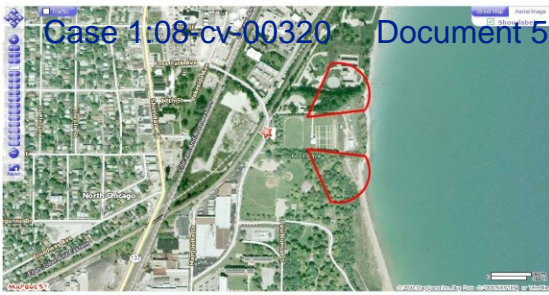
Ricochet area based on NSSD worker being struck and equal area mirrored onto Foss Park

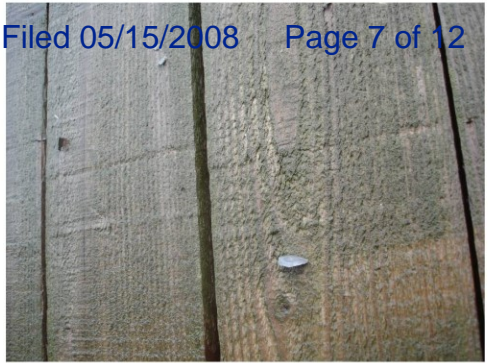
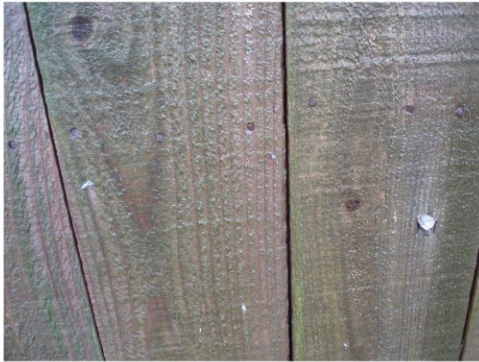
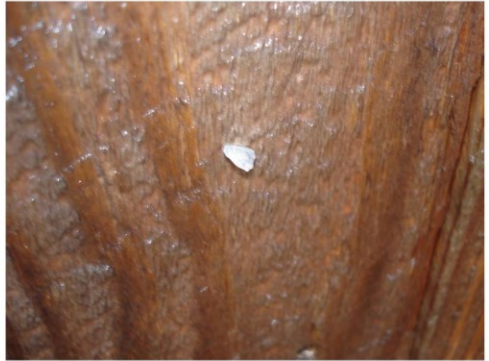
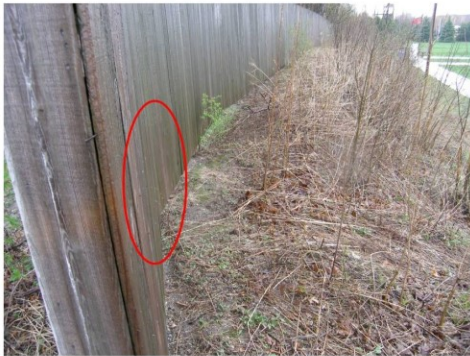
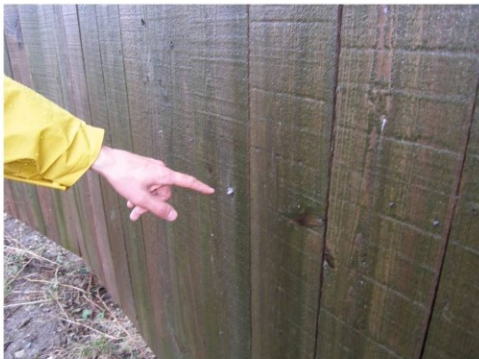
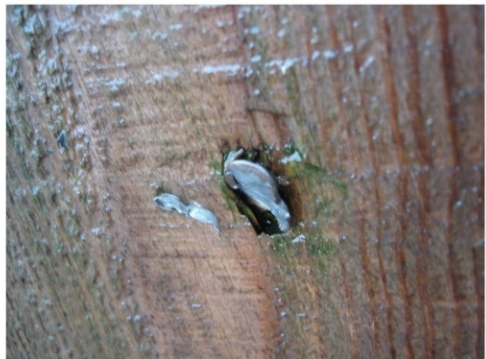
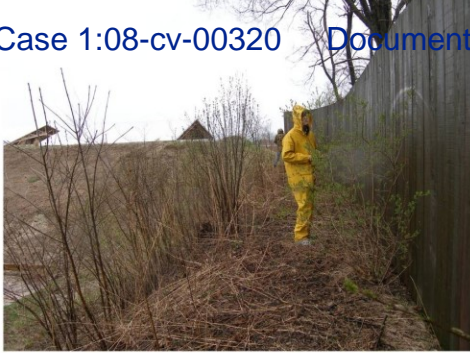
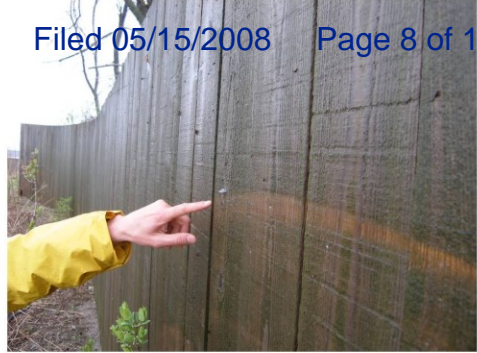
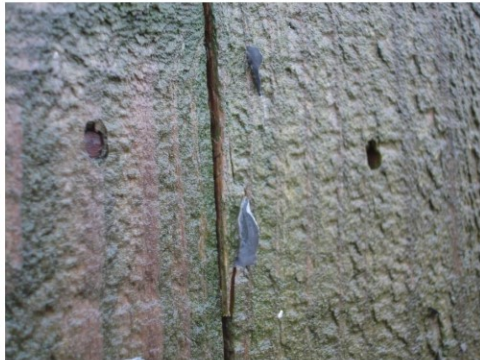
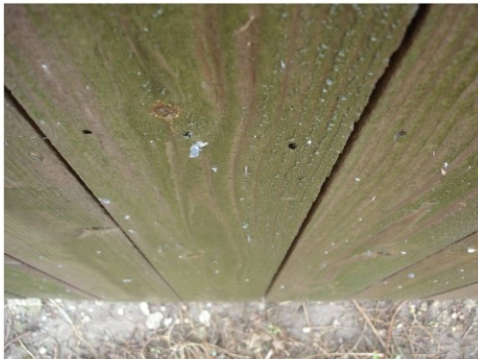
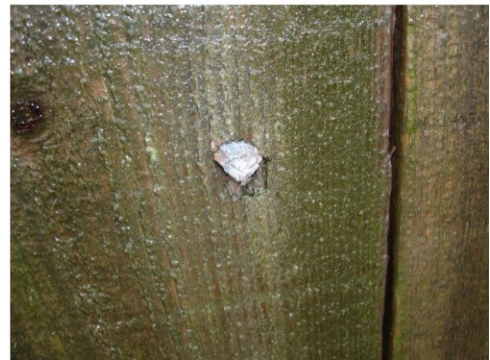
Evidence of ricochets in the south fence separating the range from Foss Park, including multiple embedded fragments and a bullet lying at the base of the fence, support my previous conclusion that the bullets I found in Foss Park on March 26, 2008 were the result of ricochets from the range.

Ricochet on inside of south fence near Foss Park

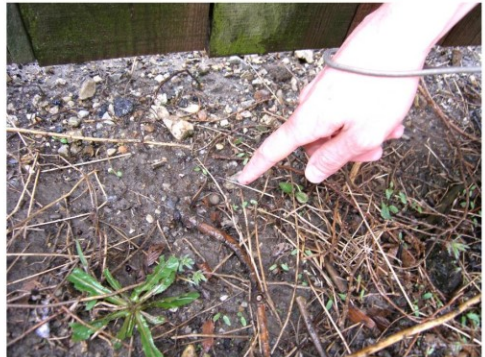
Bullet on inside of south fence near Foss Park

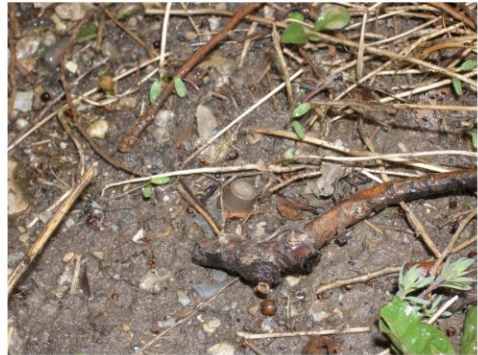
Bullet on ground inside south fence near Foss Park

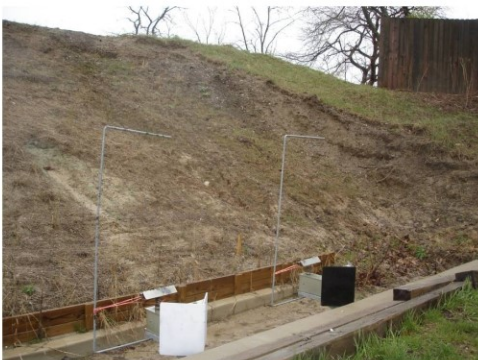
Ricochet plates near south fence

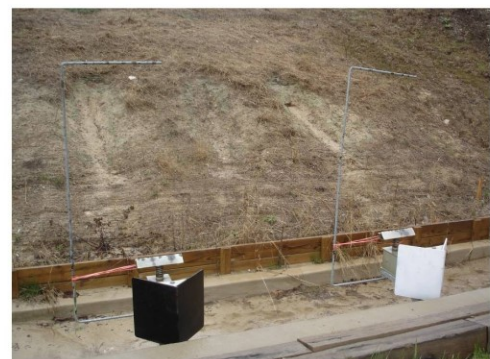
Despite an attempt to cosmetically conceal evidence of numerous bullet strikes on some exposed metal surfaces, bullet strikes were still visible; bullet strikes were also observed on concrete walkway surfaces, railroad ties, steel deflector plates, and various other metal appendages located in front of the earthen impact berm.

Ricochet plates and target holders showing indications of having been struck

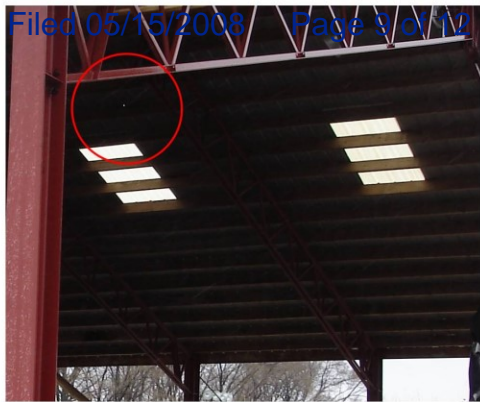
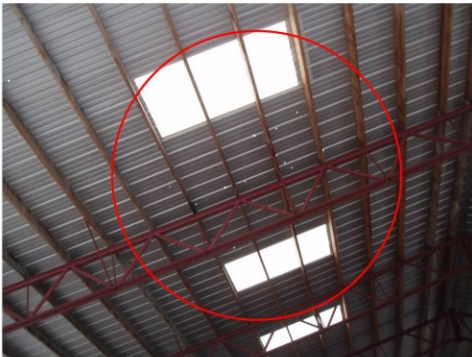
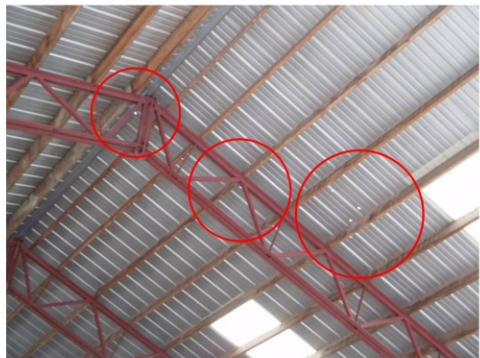
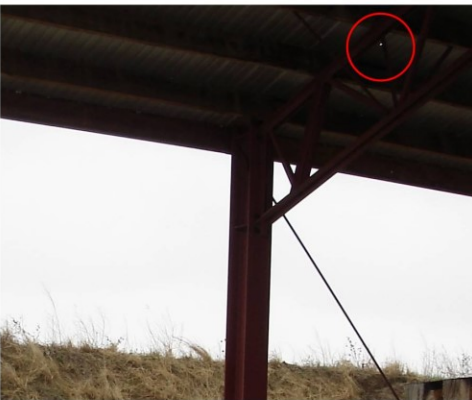
8. Behind the earthen impact berm are two large structures known as shoot houses, which are used for live fire tactical training; the northern structure appears brand new and unused, while the southern structure appears to have been used extensively in the past.
9. The roofs of both shoot houses are raised several feet above the outer most walls, providing an unrestricted 360° escape vector for projectiles emanating from within. The metal roof of the southern shoot house currently in use reflects the velocity of these projectiles, as both the east and west slope bear numerous holes through which daylight can be seen.*

Shoot house with holes in roof

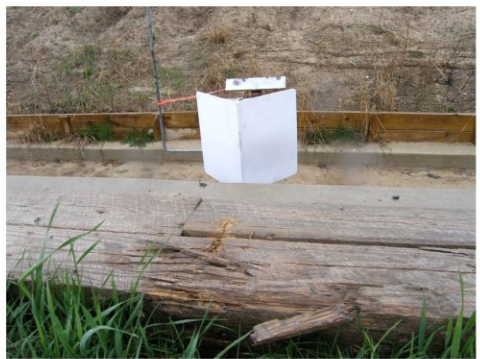
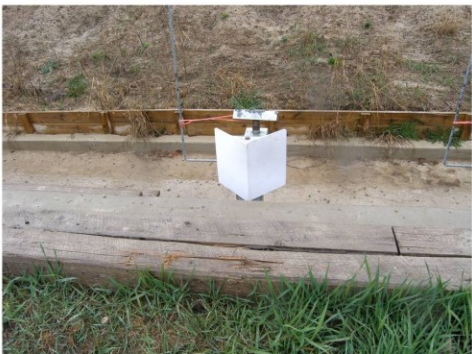
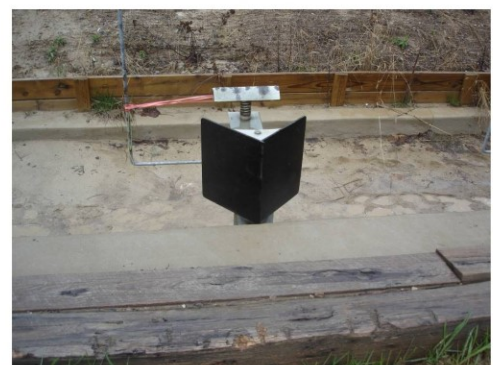
Railroad tie with ricochet mark

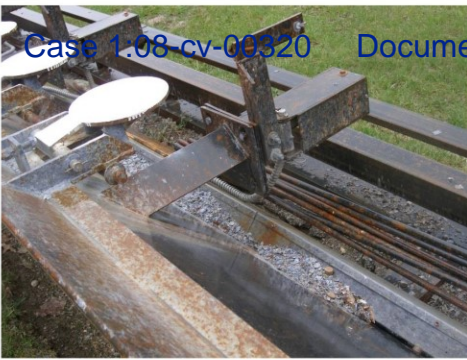
Stored in the immediate area of the north section of the range are several free-standing steel plate targets of various sizes and shapes. The grass foreground in front of the target area is slightly irregular as are some of the steel bases attached to the free-standing steel plate targets.

The ability of the flanking protective walls, therefore, to contain ricochets from ad hoc placement of moveable steel plate targets is highly variable and dependant on their angle of placement.

Knock down targets on north range

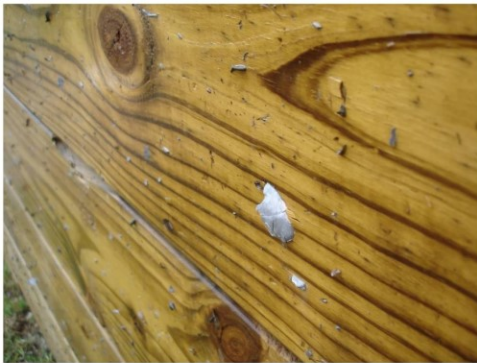
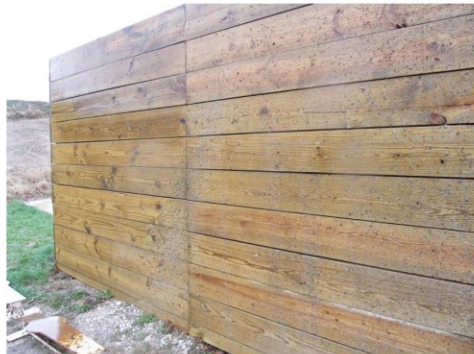
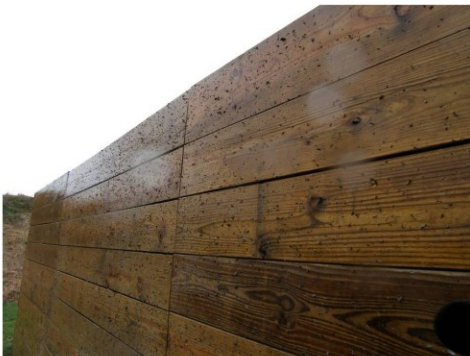
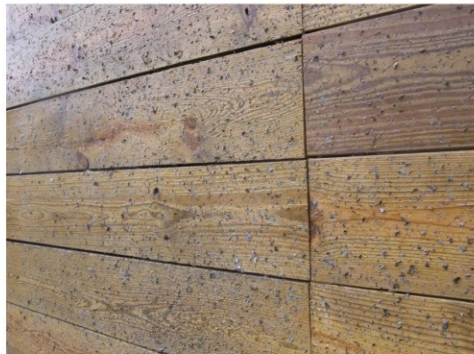
4. Lead bullets and high velocity fragments are imbedded in wooden protective fences and barricades on both the north and south range from top to bottom, an indication that higher ricochets would be leaving the facility.

Ricochets in north range fence

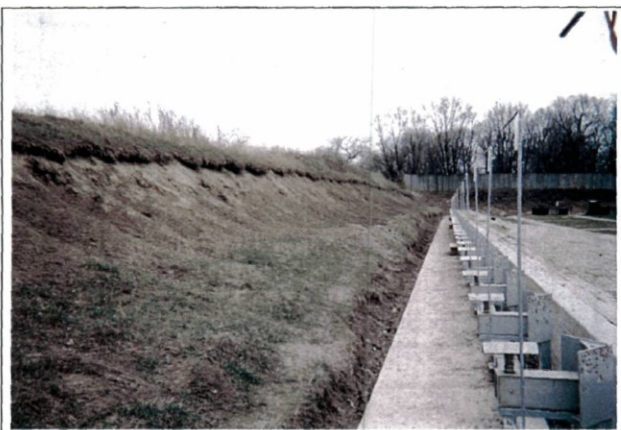
Ricochet marks in lower right ricochet plates
Picture from 2006 FBI Chicago Facility Lead
Recovery Project. Bates Stamped FBI001023

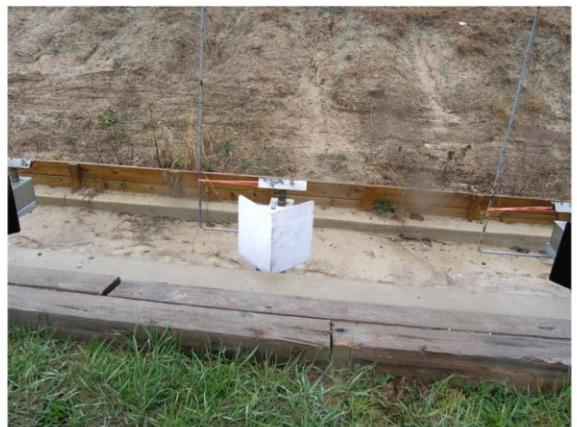
Ricochet plates showing indication of patching
and painting. Picture from April 28, 2008 range visit
